EROSION & RUNOFF MITIGATION STUDY

NORTH BAY-MATTAWA CONSERVATION AUTHORITY

Final Report
February 5, 2016

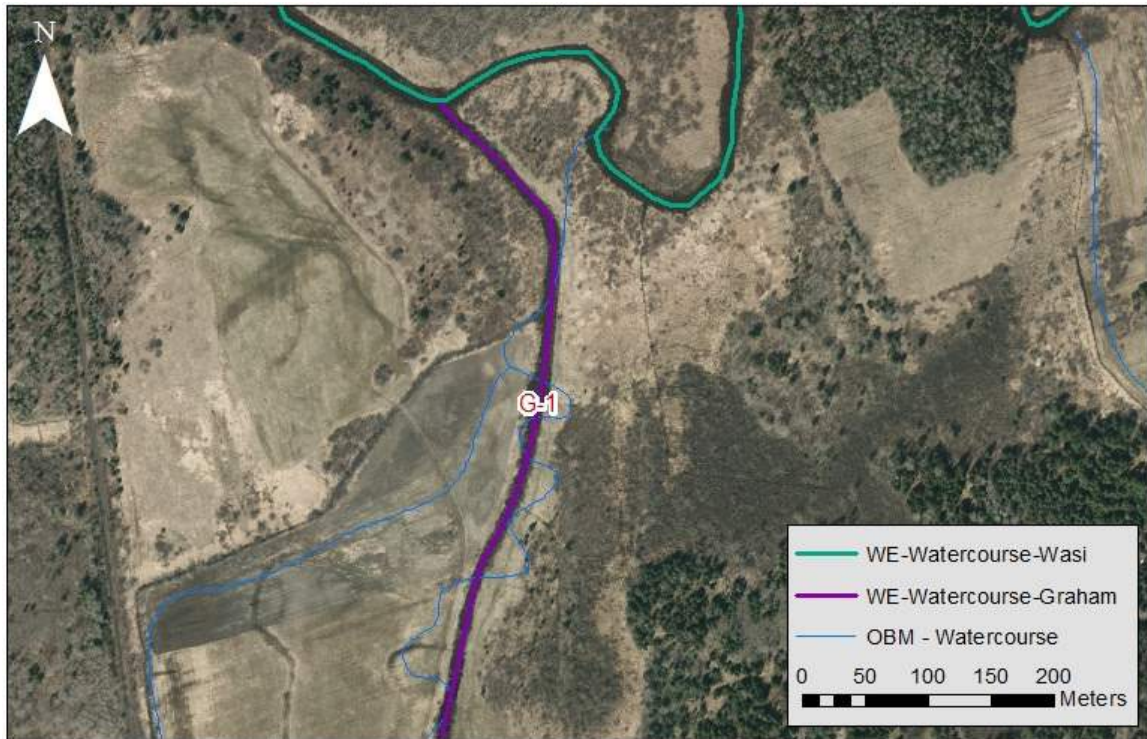
Figure 2.7: Channelization along Graham Creek.

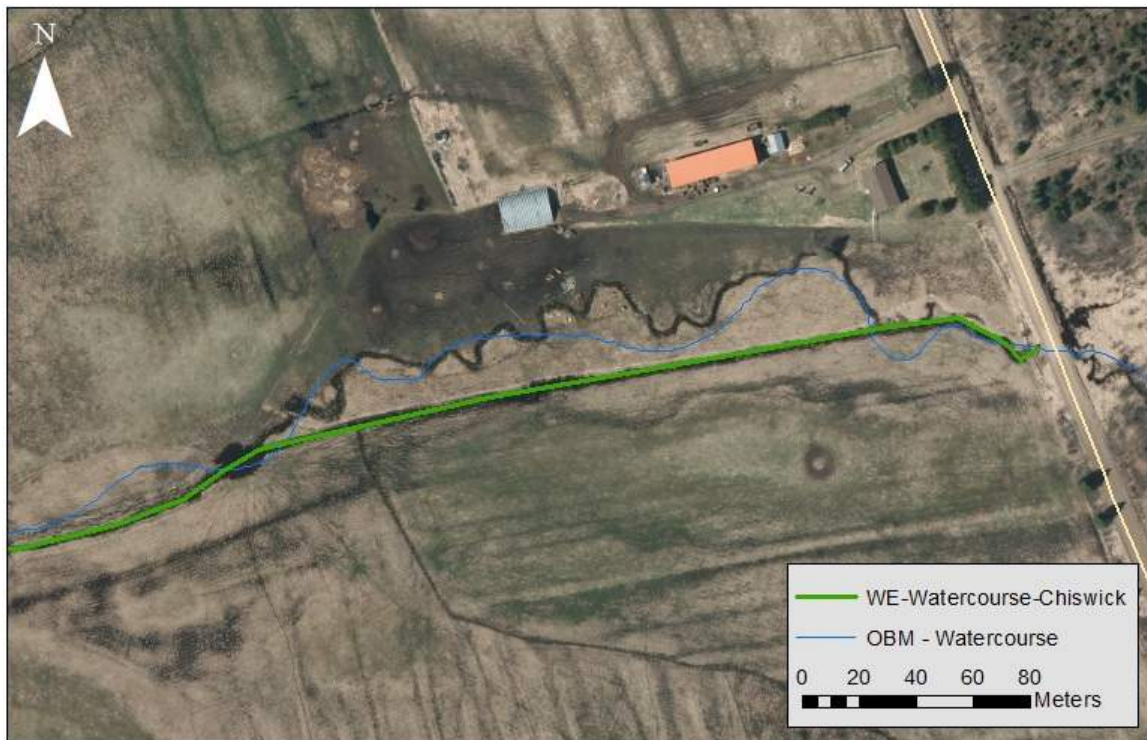
Figure 2.8: Channelization along Chiswick Creek.

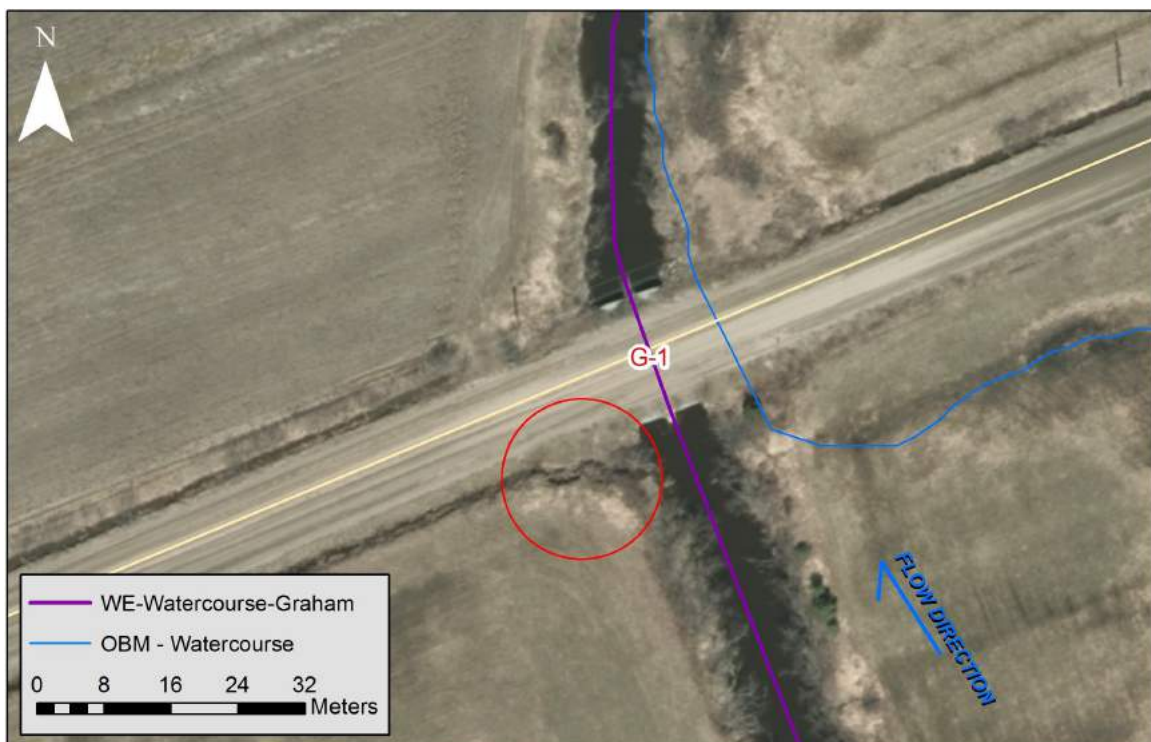
Figure 2.9: Roadside ditch eroding steep banks of channelized portion of Graham Creek (red circle).

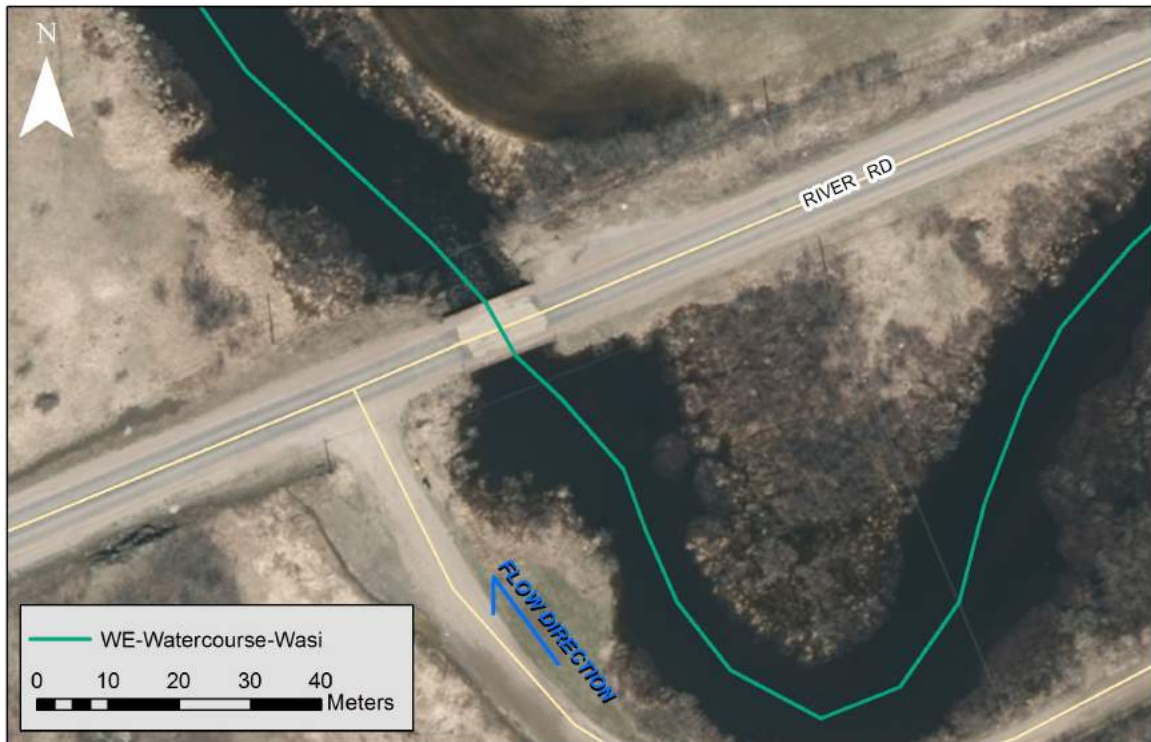
Figure 2.10: Undersized crossing span relative to channel geometry.

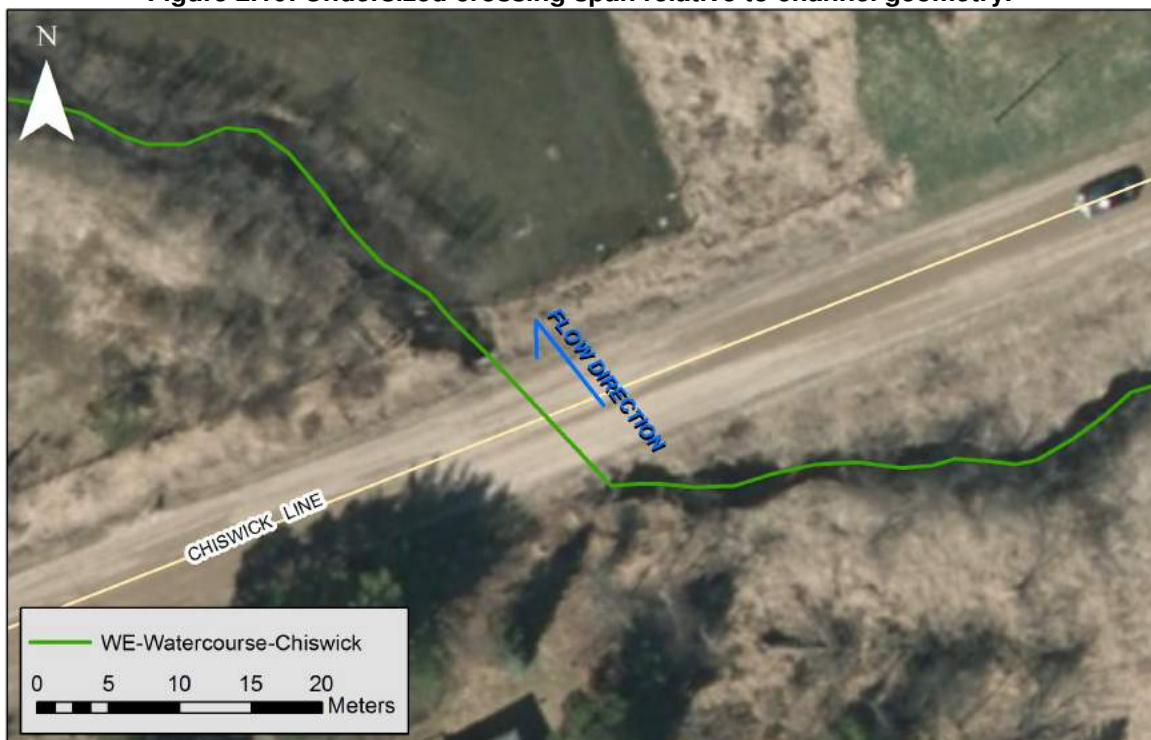
Figure 2.11: Undersized crossing span, and inappropriate skew. Tight bend at culvert inlet.

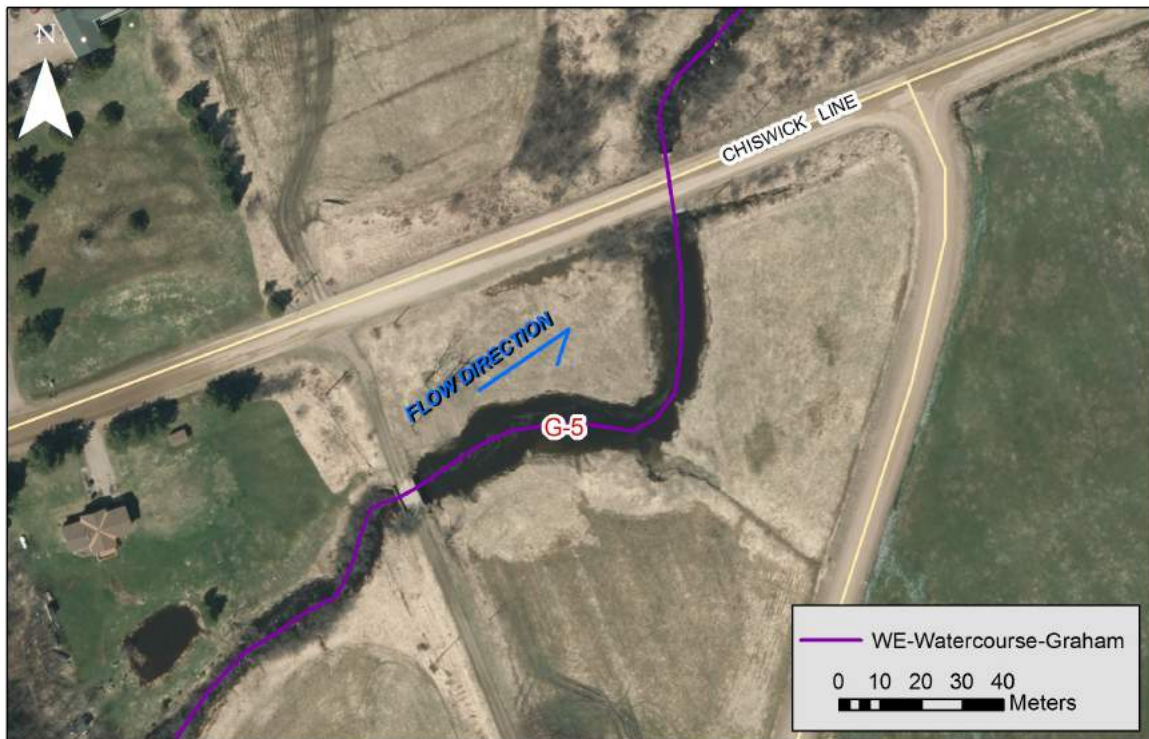
Figure 2.14: Lack of vegetated buffer, mowing to the top of bank, and bank slumping.

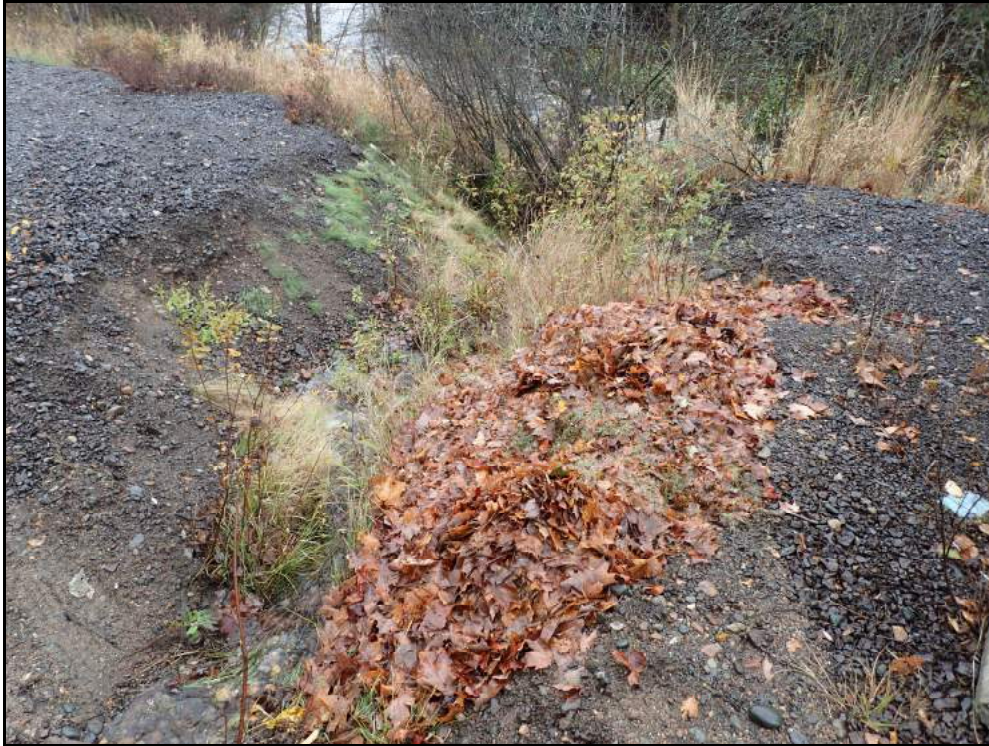
Figure 3.4: Gullying into rail embankment (photo taken leaning over barrier).

- c. Assess road and rail embankments adjacent to major watercourses to identify sites for remediation (e.g. gullying, failure) as these may potentially pose major risk to human populations.

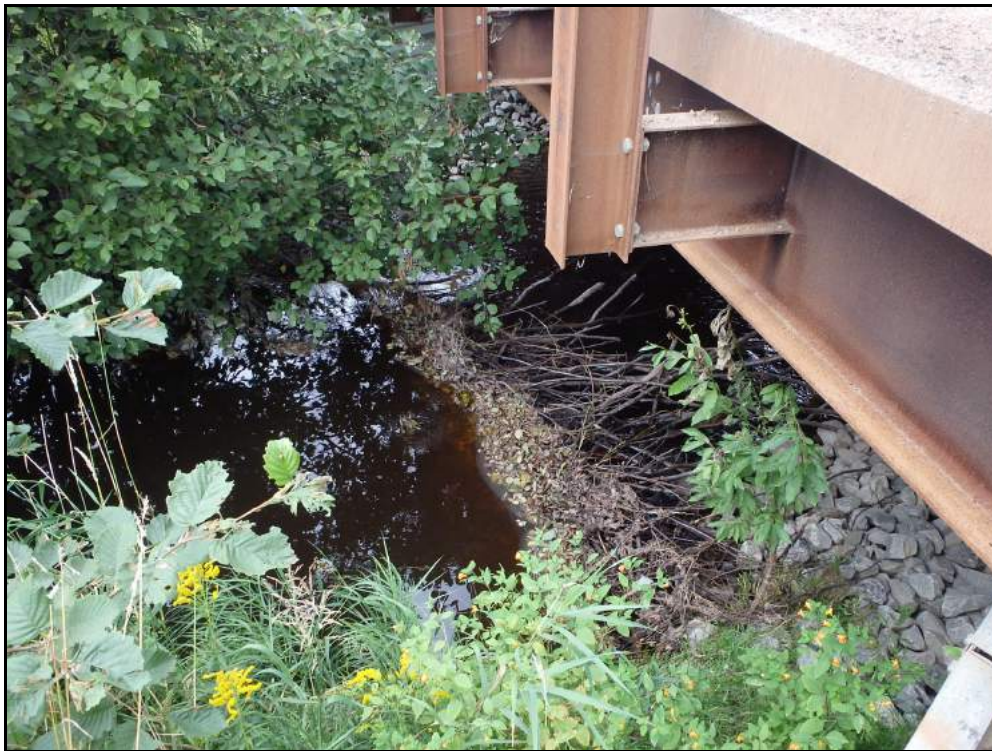
Figure 3.7: Beaver Dam in Graham Creek under Memorial Park Drive.

- d. Monitor beaver dams and debris jams for stability, erosion, and flooding issues
3. Construction opportunities
- a. Retrofit existing municipal parking areas with rain gardens or infiltration trenches to control/treat runoff from summer storms, and meltwater from snow piles.

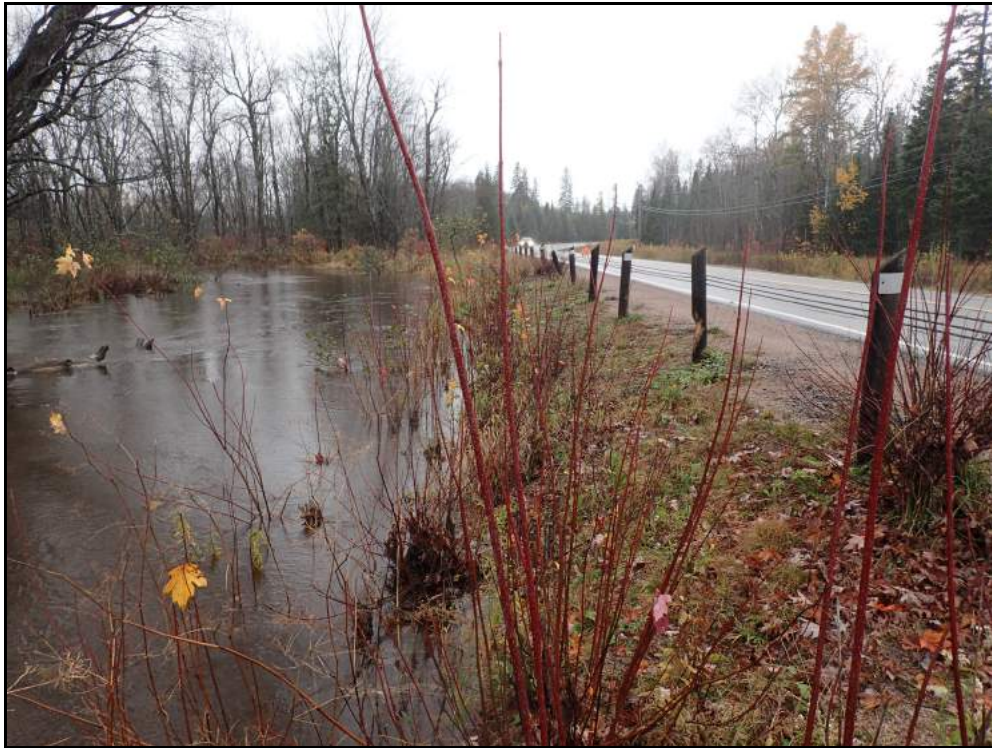
Beaver activity is not limited to damming watercourses. Tree removal by beavers should be monitored, mainly for ecological purposes, but also for bank stabilization. Within Reach W-3, beavers had begun to chew through some of the posts on the road barrier between Lake Nosbonsing Road and Wasi River (**Figure 3.8**)

Figure 3.8: Wasi River Reach C-3 – Beaver damage to guardrail posts.

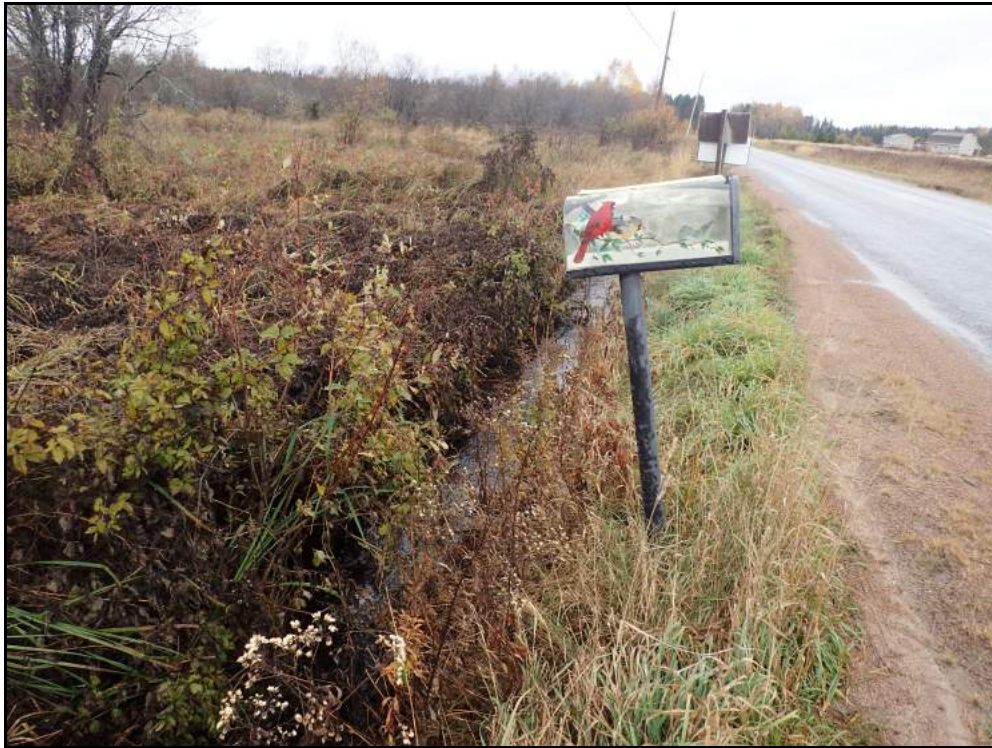
Drainage along road embankments is a common and necessary feature where sub-surface drainage (storm sewer) networks are not constructed. Issues arise when ditches are not designed to convey the water delivered to them, or when flow is re-routed to these ditches to increase available land area for development activities. Like rivers, ditches will respond morphologically to increased flow, and are particularly susceptible to bank failure because road fill is comprised of poorly sorted, unconsolidated sands and gravels. **Figure 3.9** shows a leaning mailbox because of undercutting of the road embankment along a steep ditch parallel to Alderdale Road. A number of alternatives exist from natural channel design to implementing check dams to manage velocities and shear stress.

Figure 3.9: Undercut road embankment. Alderdale Road at River Road – Graham Creek.
