EROSION & RUNOFF MITIGATION STUDY

NORTH BAY-MATTAWA CONSERVATION AUTHORITY

Final Report
February 5, 2016

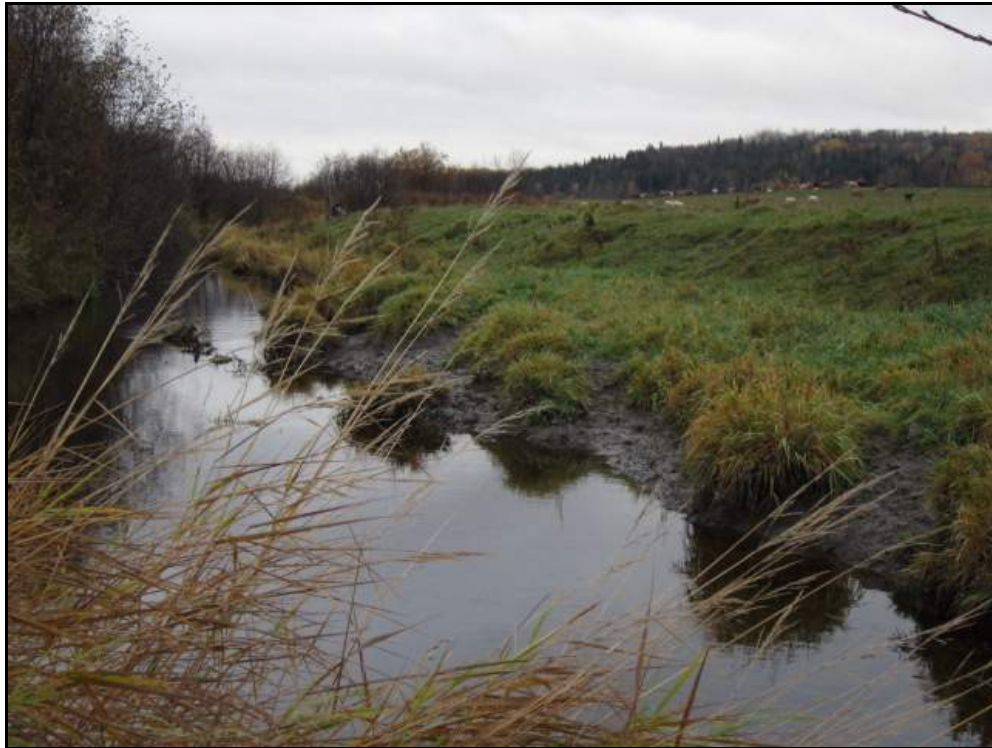
Certain locations through Graham Creek, Chiswick Creek, and Wasi River (upstream of Wasi Lake) had open fields for grazing with cattle access to the watercourse (**Figure 2.13**). The 2012 Riparian Assessment also found locations where there was grazing through a forest on the lower sections of Wasi River, and certain smaller tributaries in the upper reaches that cattle were crossing. Cattle movement along and down streambanks weakens the structural integrity and material can become dislodged. Direct discharge of waste is also probable in these situations. The 2012 Riparian Assessment recommended locations which should be fenced-off from cattle.

Figure 2.13: Bank slumping and cattle access – Graham Creek Reach G-3. (Martens, 2012).

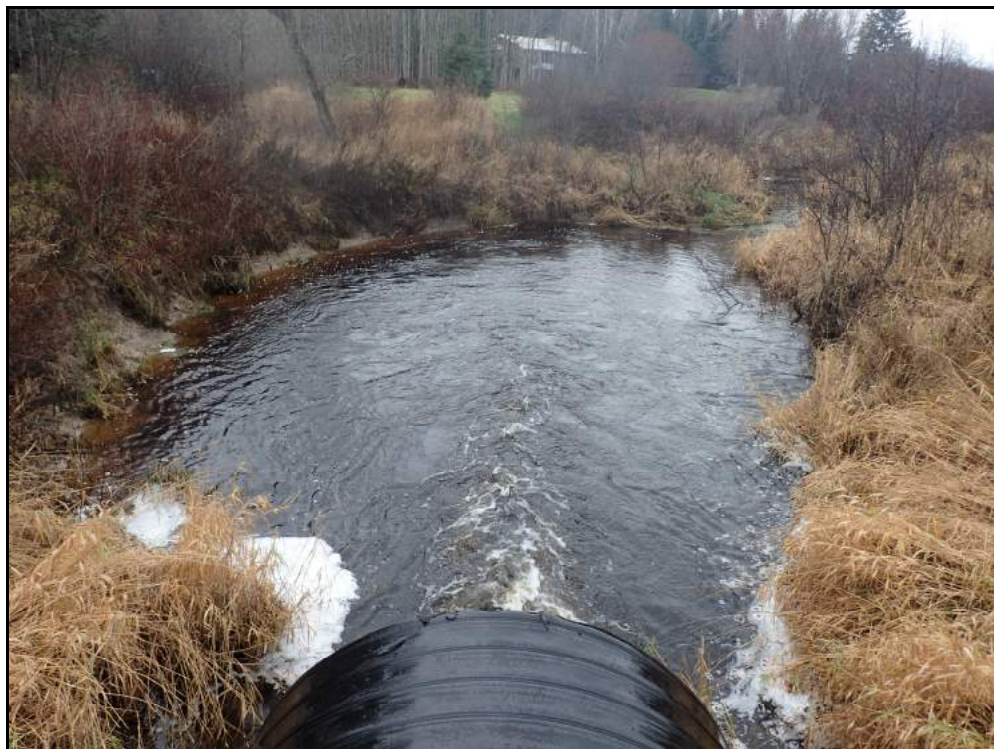
Immediately downstream of Pinecreek Road a steep slope along the left bank shows signs of active erosion, and the landowner had expressed some concern with the “rapid” bank failure causing the top of slope to retreat (**Figure 3.2**). This slope was found to have a high potential for slope instability with a score of 40 due to the presence of the following indicators: previous failure, a steep slope angle, moderate vegetation cover, drainage over the surface, and the proximity to the active channel.

Figure 3.2: View downstream from Pinecreek Road and eroding left bank.

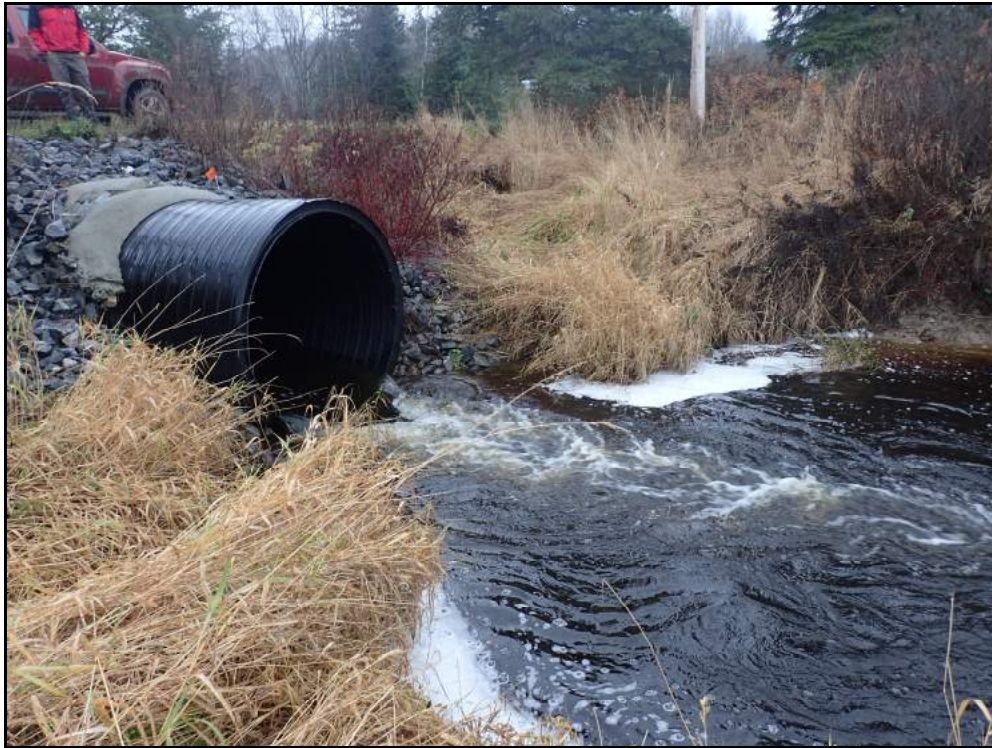
The Pinecreek Road culvert was apparently replaced or lined in recent years (landowner correspondence), and rip rap stone protection surrounds the structure along the road embankment (**Figure 3.3**). It is corrugated plastic, circular, with a diameter of approximately 2.0m, and the invert was located 0.1m above the water surface downstream during the field surveys. This perched culvert above the water surface exacerbates erosion issues due to the

For properly sized culverts, prevailing flows (e.g. 2 and 5-year flood events, or greater) are often conveyed without significant convergence and divergence, upstream and downstream, respectively. At the Pinecreek Road culvert, the undersized effect is also observed under lower flow events because of the circular shape of the culvert cross-section. As flow depths drop in the culvert, the cross-section area for flows to pass becomes drastically reduced towards the invert. Even under low-flow conditions, flows will likely converge into the culvert, increasing velocities, and creating the potential for erosion downstream.

Figure 3.3: Pinecreek Road culvert outlet. Note the perched culvert.

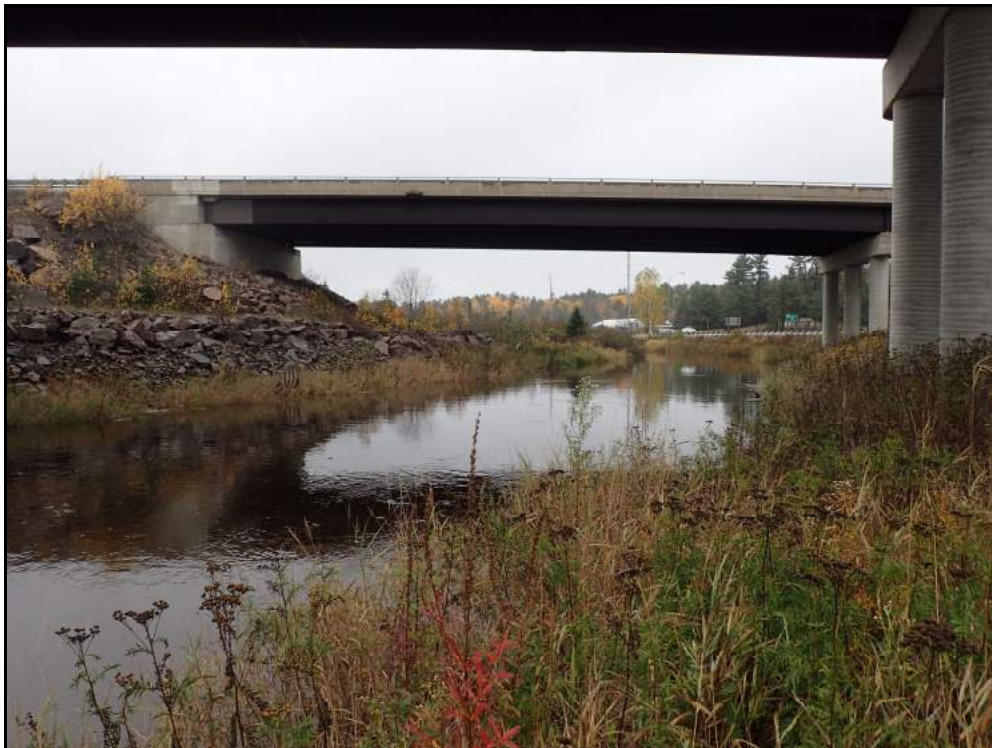
Figure 3.5: Wasi River looking downstream under Highway 11.

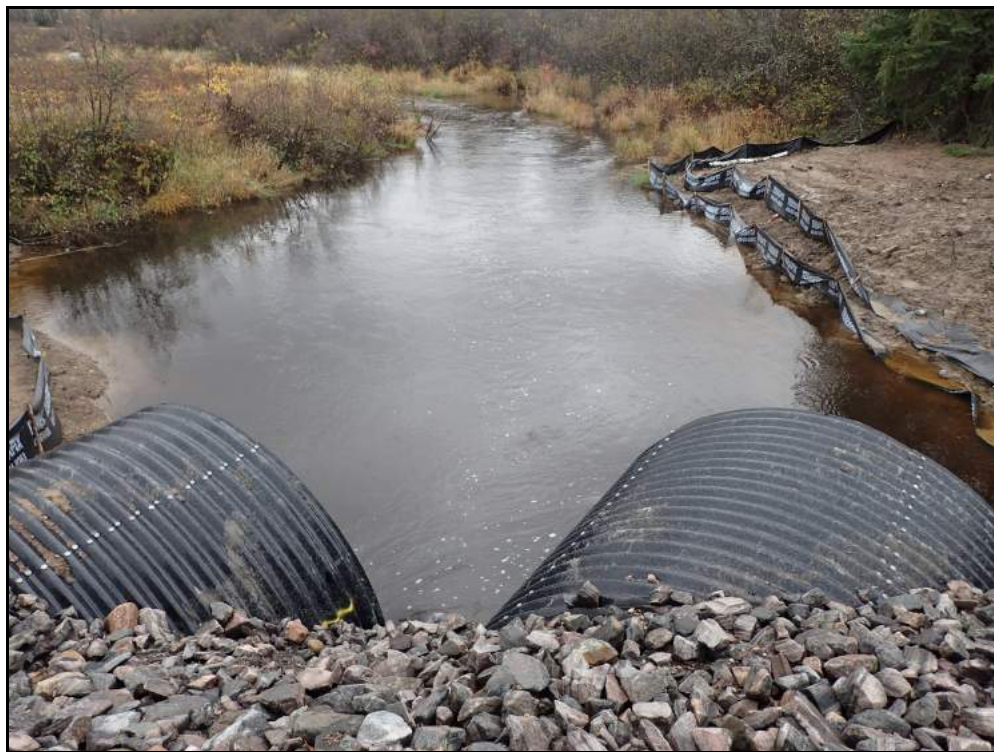
Figure 3.6: Wasi River looking upstream from Astorville Road.

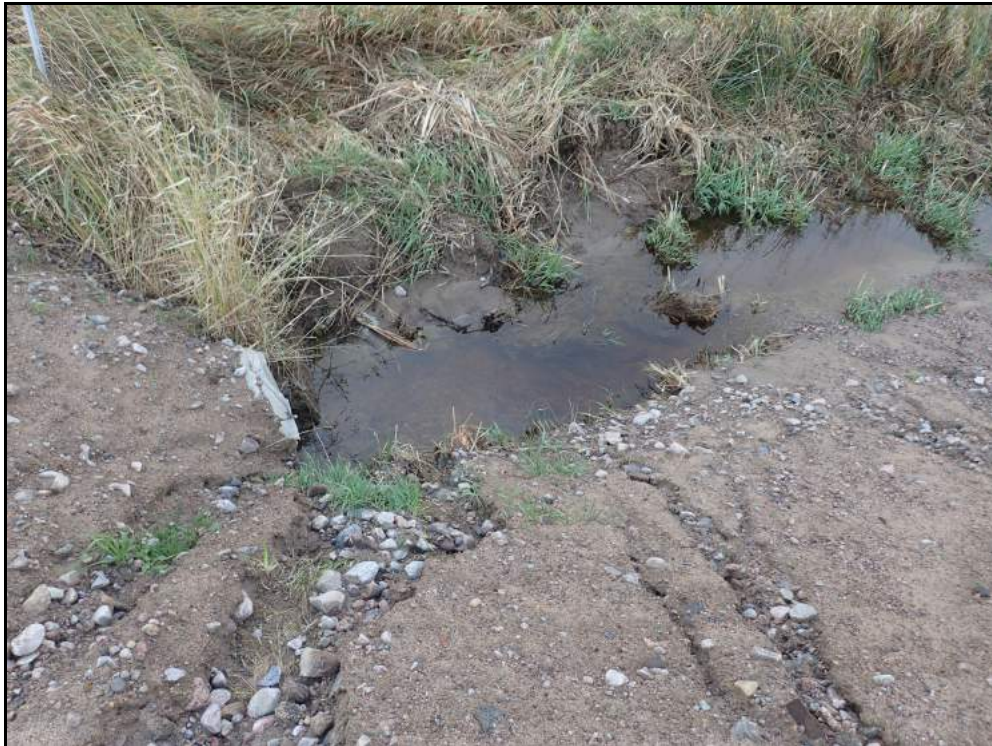
Sand/grit application and road fill erosion (rill and gully formation) contributes sediment to the system. This occurred throughout the system, particularly where road slopes are steep, and where banks lack cover, causing exposure to runoff and rainfall impact. **Figures 3.10 and 3.11** provide examples of rill erosion due to runoff, and sand delivery from the road, respectively. As it is unlikely that grit application will cease in an area that experiences long winters, management practices should aim to slow runoff and capture sediment above and on the bank slope.

Figure 3.10: Rill erosion along road embankment – Graham Creek.

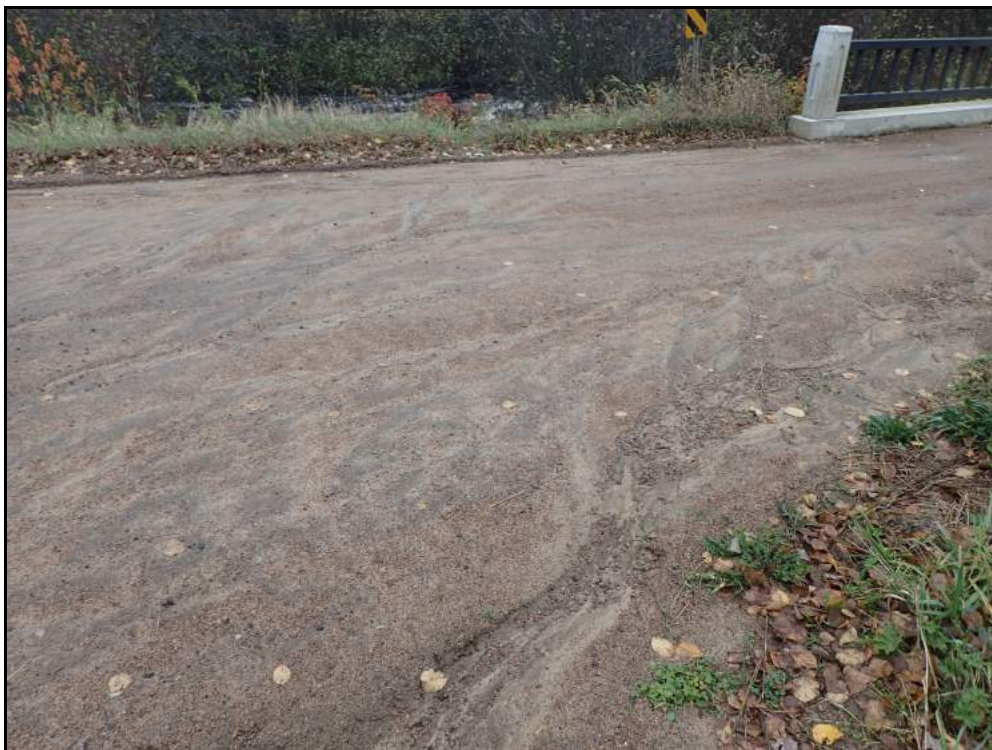
Figure 3.11: Sand erosion and transport towards Wasi River at Wasing Road.

To reduce the delivery of sand/grit to watercourses from roads, erosion control measures can be applied along the top of slope where road embankments form the valley slope (see **Figure 3.11**). Frequently, silt-fencing is staked along valley corridors to reduce sediment delivery from nearby construction. Natural earth-berms, coir logs with seeding, and filter socks, can be applied in a similar fashion to silt fence where road sand/grit is a potential source for excess sediment to area watercourses.

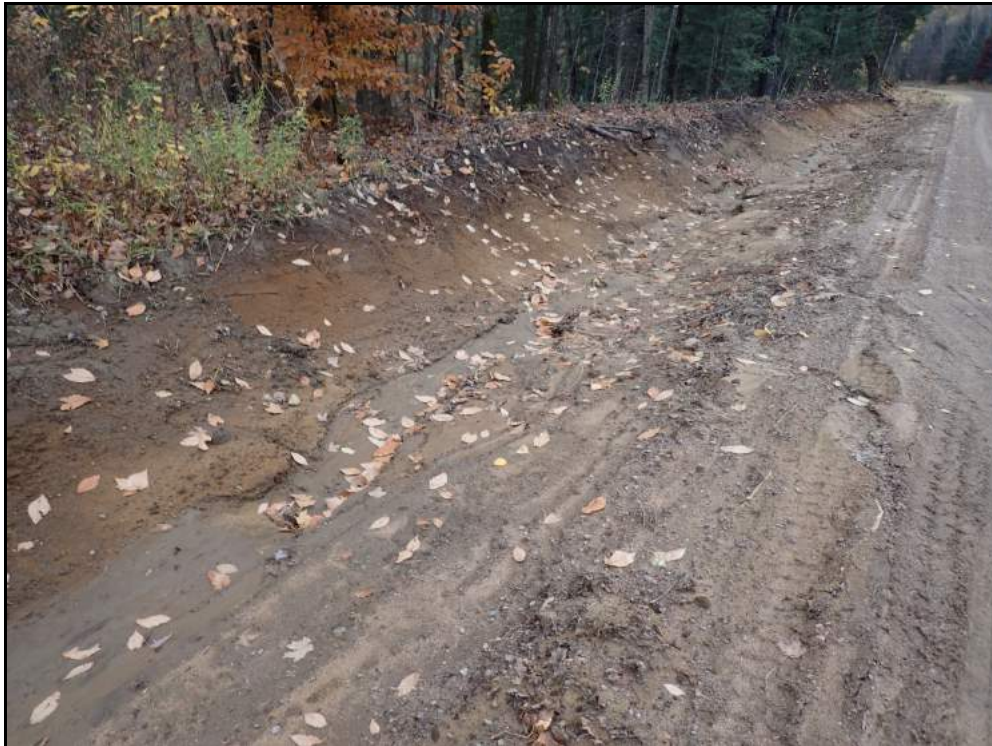
Headwaters for Graham Creek and Wasi River both originate on top of an escarpment. The upper reaches of each are relatively steep through glaciofluvial sands and gravels, or bedrock outcrops. Similarly, roads that access the upper watershed are also very steep, with rapidly eroding drainage ditches. During the windshield assessment, staff drove south on Maple Road from Pioneer Road which leads up the escarpment. This road has very steep sections with a large roadside ditch that appears to recently have been enlarged – there were bucket marks from an excavator. Sands are readily transported frequently downslope under even the slightest events (**Figure 3.12**). The runoff reaching this drainage ditch may increase as land is cleared of trees to build housing. Two upper reaches of Graham Creek intersect Maple Road at low points partially down the slope of the escarpment, where sediment is discharged (**Figure 3.13**). Eventually these two watercourses converge and discharge to Graham Lake. Grade control within the roadside ditches and possible armouring may be necessary mitigation measures. Land clearing and other construction works should have adequate erosion and sediment control plans and inspections.

Figure 3.12: Recently excavated roadside ditch along Maple Road. Fine sands are easily transported down-slope.

Despite Graham Lake acting as a sediment sink in the upper catchment, the upstream source along Maple Road should be monitored.

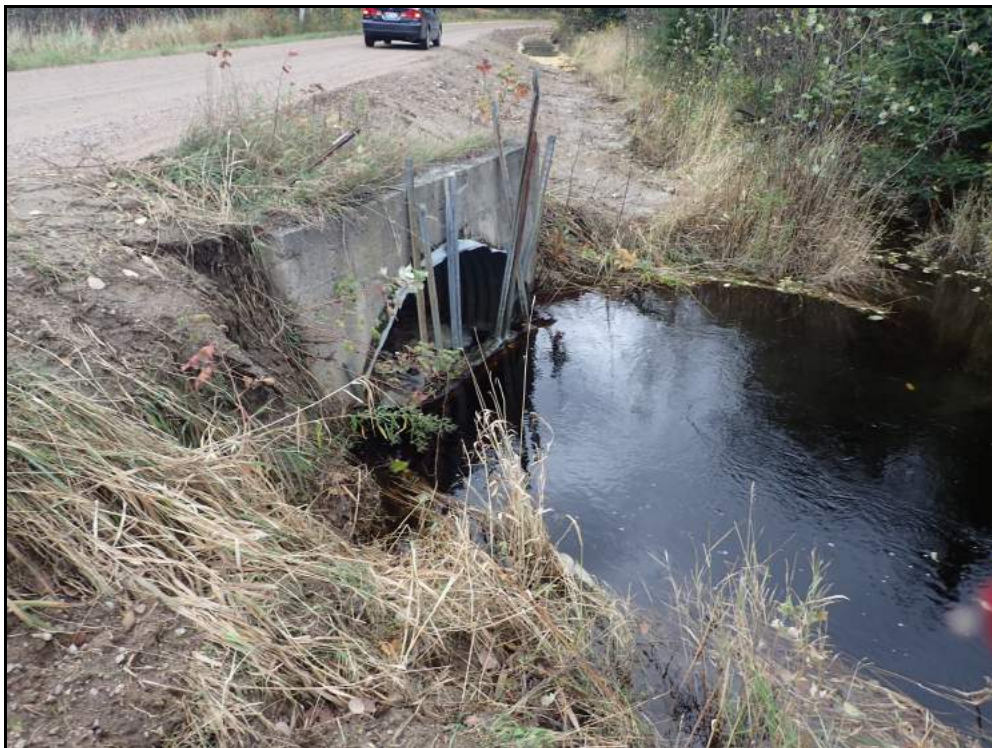
Figure 3.13: Sediment discharge from roadside ditch to Graham Creek – Maple Road.

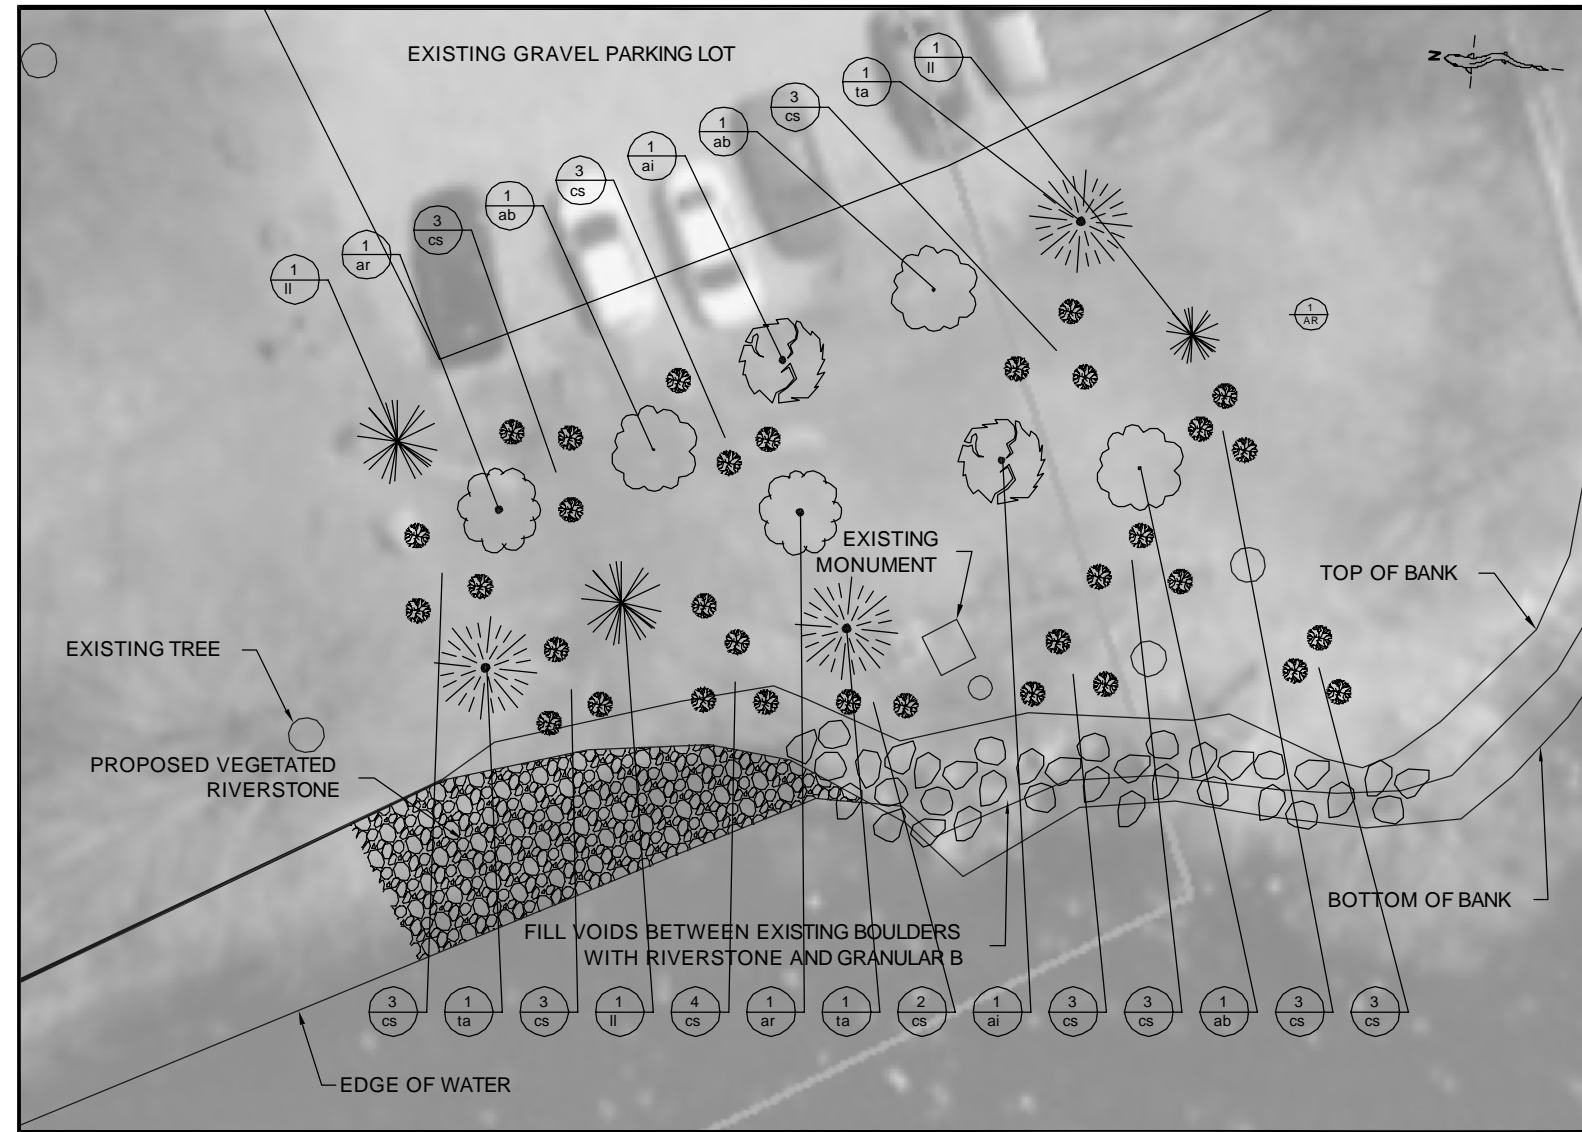
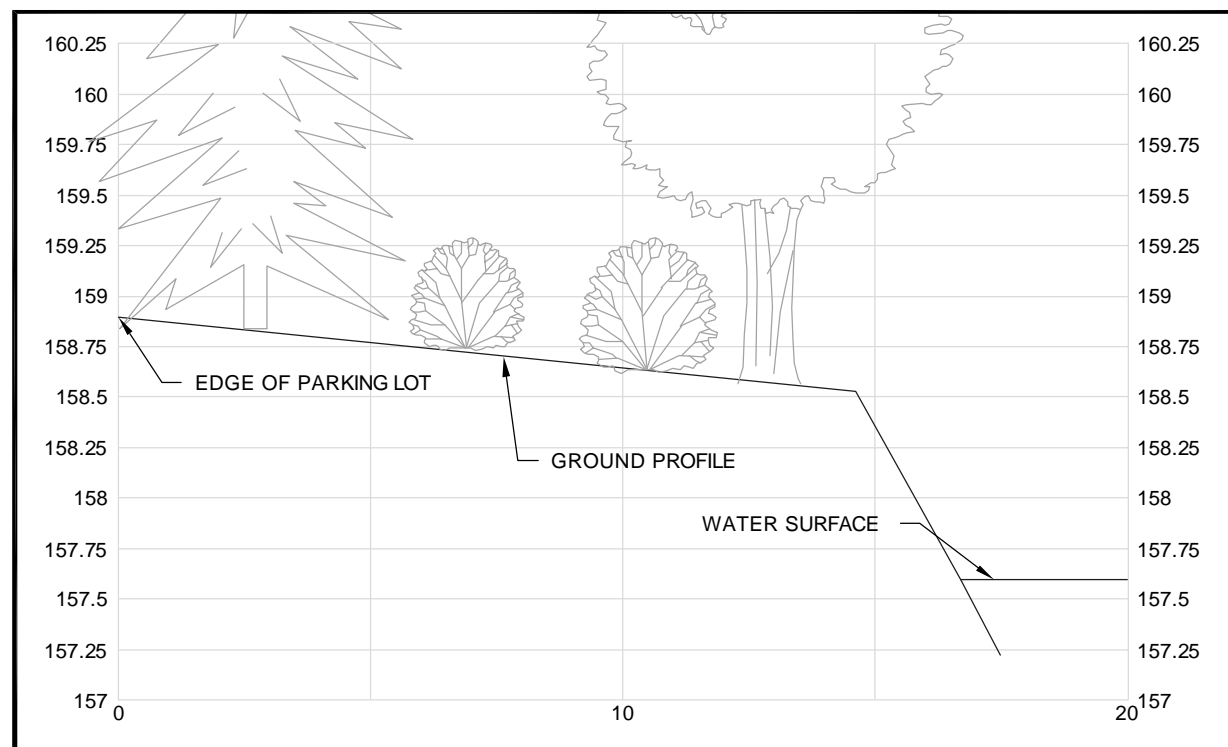
MUNICIPAL DWG NO. WE 14045-01 CAD FILENAME PP1
SITE NO. CA-1 SHEET # 1 OF 2

- LAKE ACCESS ALONG THIS BANK HAS BEEN CONTRIBUTING TO EROSION, THEREFORE WE RECOMMEND CONSTRUCTING A DOCK OVER THE VEGETATED RIVERSTONE, OR IF POSSIBLE, AT THE RETAINING WALL ON THE ADJACENT PARK PROPERTY (BOTH PROPERTIES ARE MUNICIPALLY OWNED).

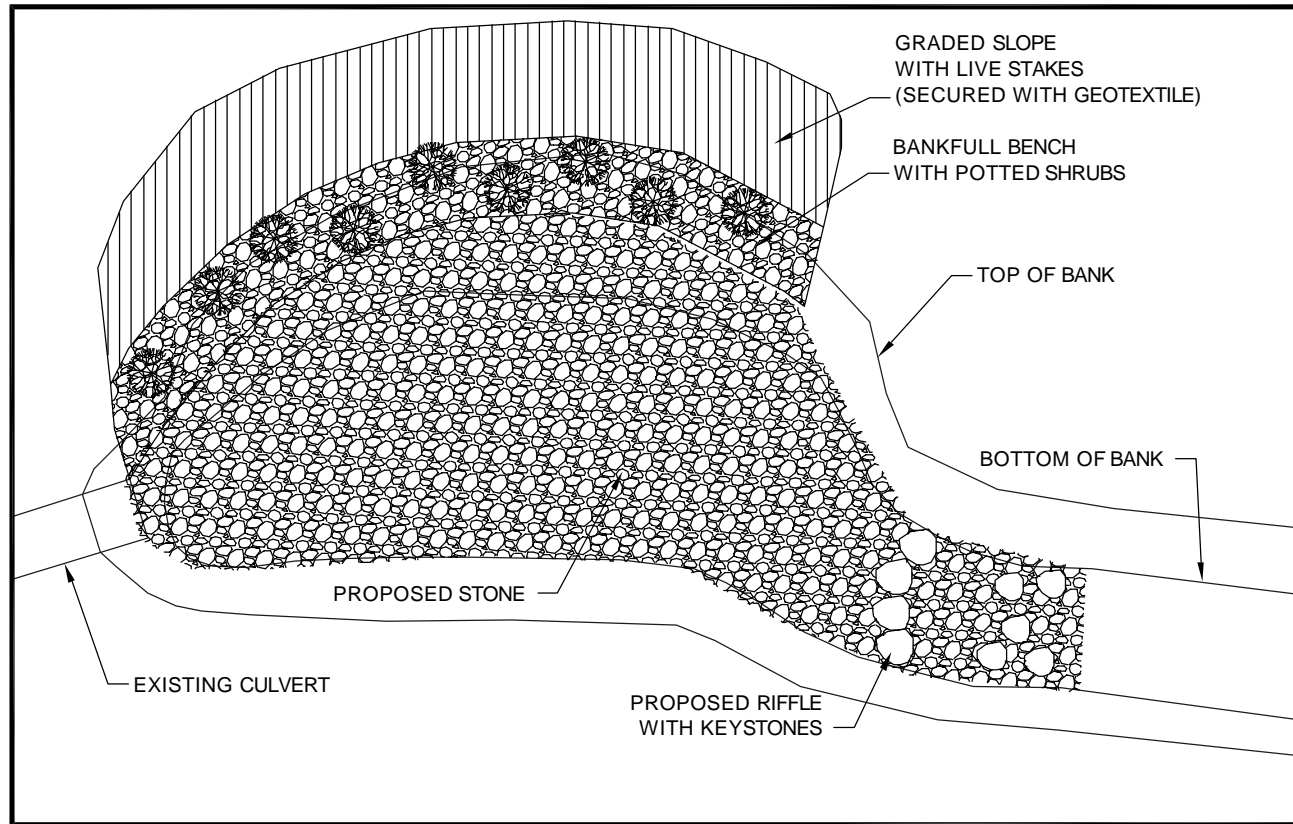
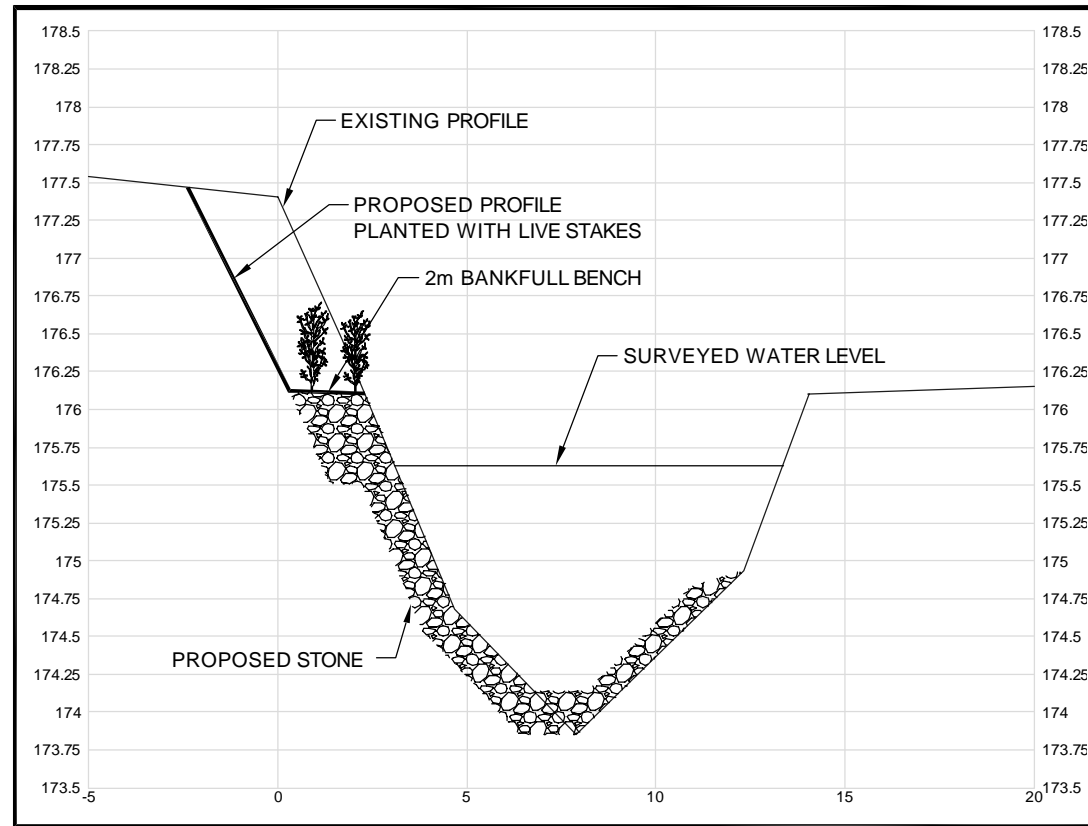
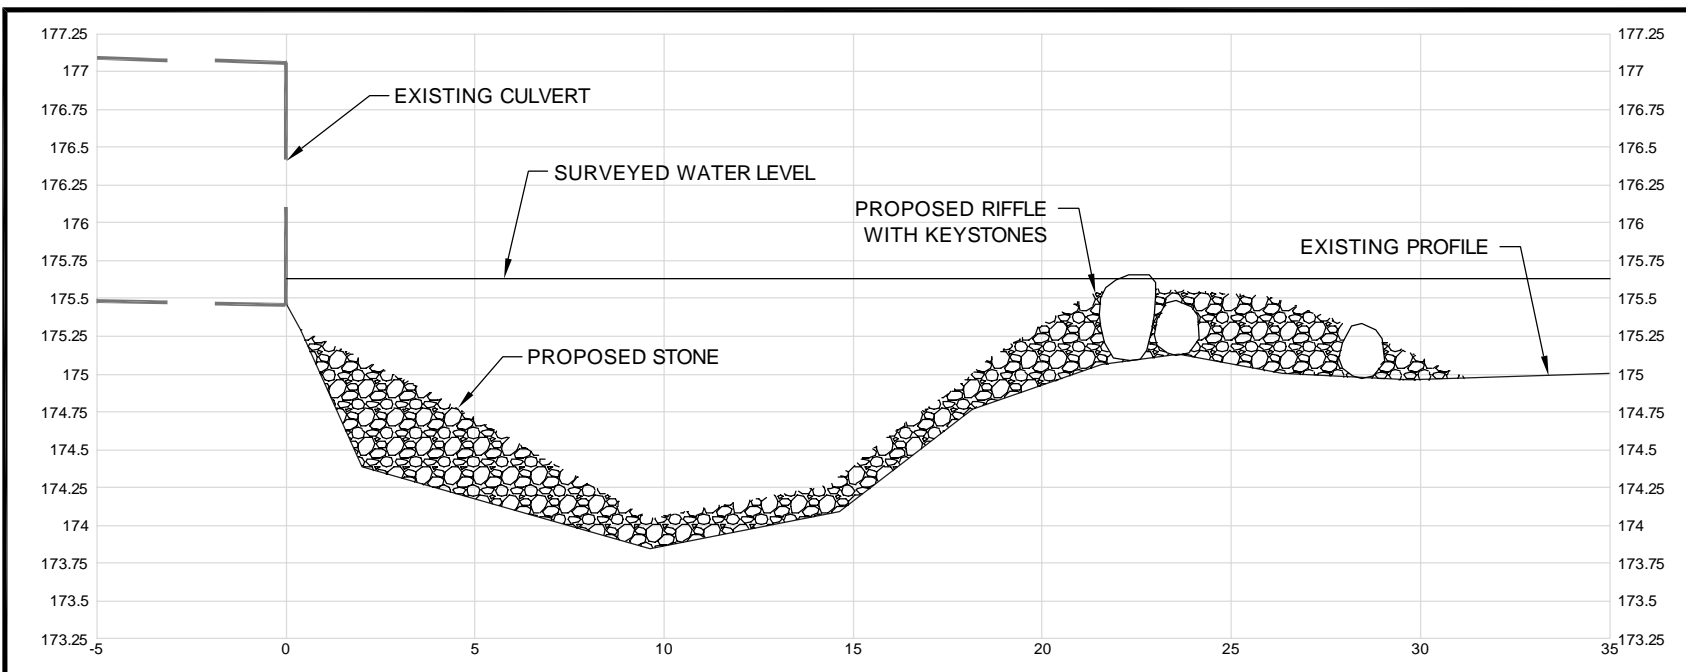
SITE 8 CONCEPTUAL PLAN

BANK EROSION DOWNSTREAM OF PINECREEK ROAD RESULTS FROM THE UNDERSIZED AND PERCHED CULVERT WITH RESPECT TO EXISTING CHANNEL MORPHOLOGY AND HYDRAULICS. PRIOR TO ANY CREEK WORK OR BANK STABILIZATION, IT IS RECOMMENDED THAT THE DESIGN OF THE PINECREEK ROAD CULVERT IS REVISITED, UPDATED, AND THAT UPGRADES ARE MADE WITH RESPECT TO CROSSING SPAN, SKEW, MATERIAL (CONCRETE BOX/OPEN BOTTOM), AND ELEVATION.
